WEATHERING

ABOUT ACCOYA®

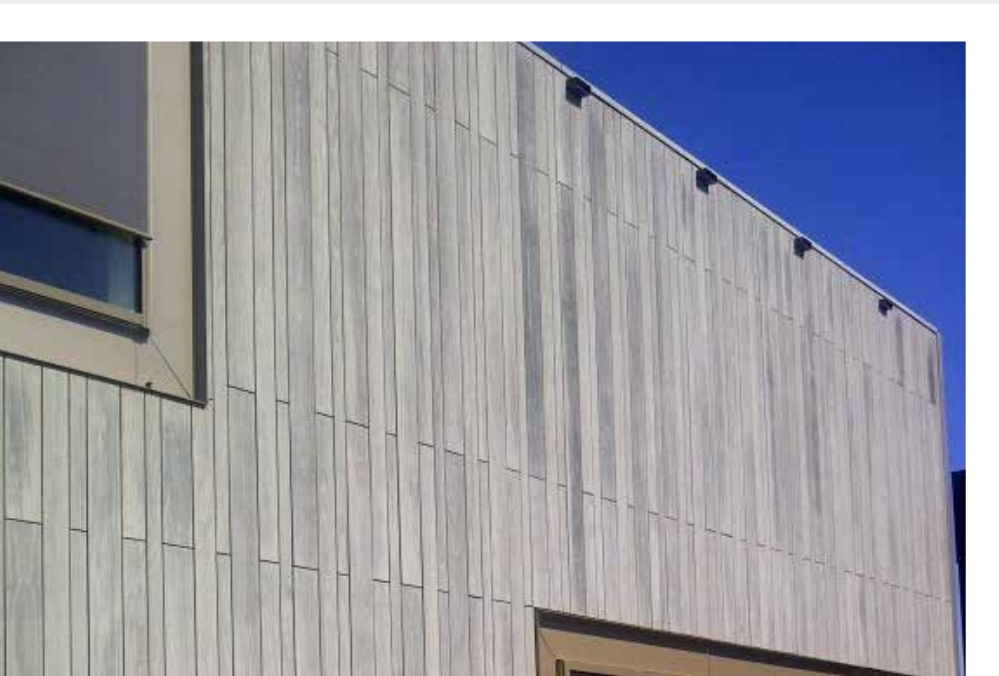
An example of such a blotchy transition period is shown in the image above (Dutch cladding project approximately a year after installation).

However, prior to turning grey, uncoated Accoya® will go through a phase of bleaching where it turns a lighter shade of its normal colour. Surface growths are particularly apparent in this intervening period and can vary in level from board to board. This will become less distinguishable and objectionable after full (even) greying, but in this transition period the surface of Accoya® may look blotchy.

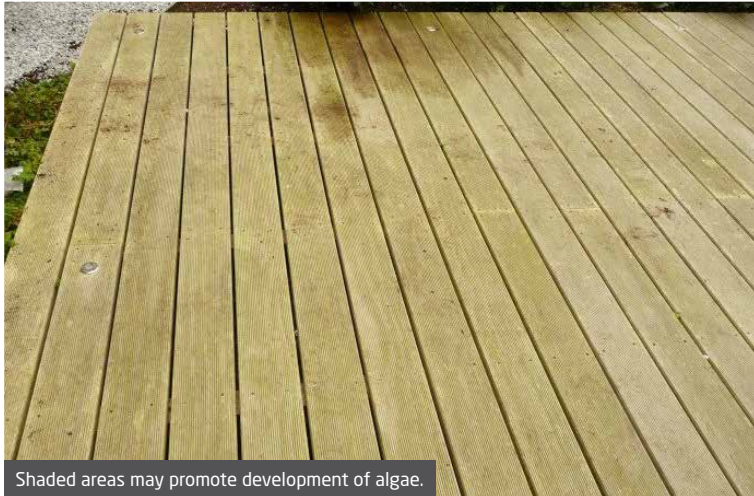
Shaded areas may promote development of algae.

A wet and a dry board may vary in appearance. Due to the installation details, the presence of a shaded area and the natural differences in the wood between boards, as for instance density variation or grain orientation, some may dry quicker than others.

Not only does this reflect on the appearance of a surface while drying, it will also have an influence on the development of moulds, algae and so on.

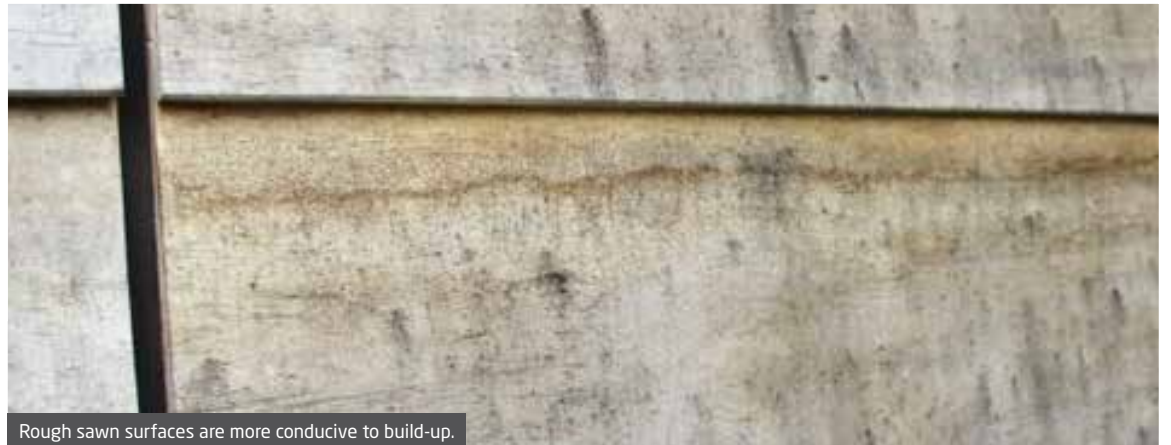
Rough sawn surfaces are more conducive to build-up.

Other influences are location specific, such as proximity to vegetation, pollution and dirt accumulation (rough sawn surface!). Lastly, the natural differences in the wood will also play a role.

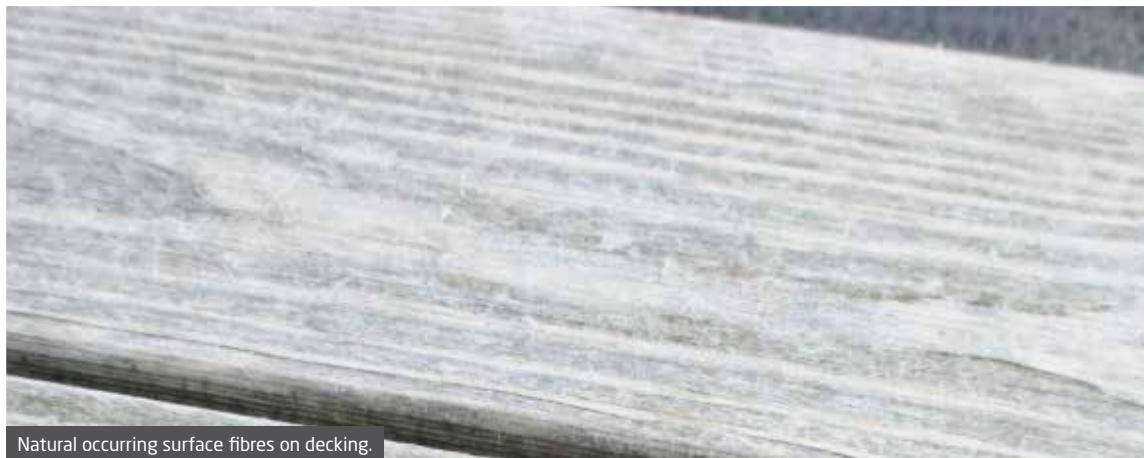
Natural occurring surface fibres on decking.

In addition to that, as explained previously, UV light (which is a part of sunlight) is responsible for partly degrading the lignin in wood surfaces. As this lignin holds the wood cells together, this degradation will lead to a rougher and more open surface. This may be perceived as fine fibres on the surface, which will eventually erode.

The higher the amount or intensity of UV the surface is subject to, the faster this process will develop. It should be noted that these fibres are formed on all exposed wood species, including Accoya®, particularly on flat surfaces like decking. A ribbed deck profile will tend to cause an accumulation of these fibres, making it all the more noticeable.

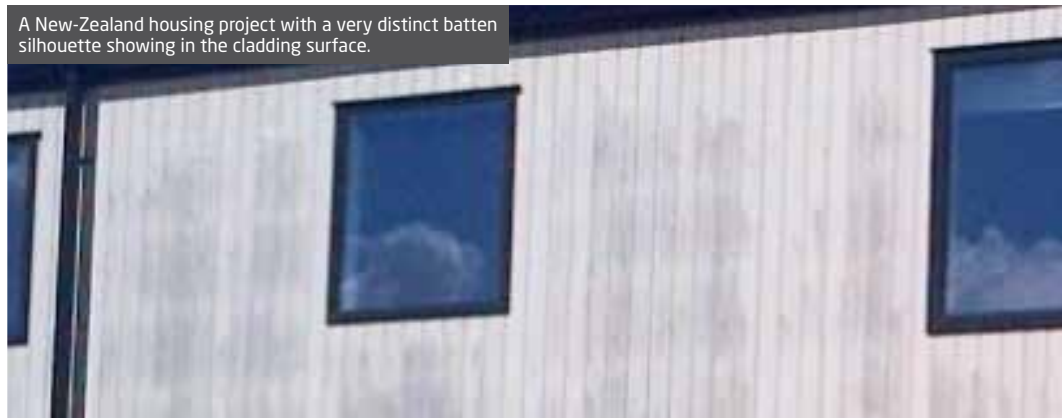
A New-Zealand housing project with a very distinct batten silhouette showing in the cladding surface.

Some projects have shown a distinct pattern reflecting the sub-frame behind the Accoya®. This is caused by heat transfer from the building to the Accoya® boards, which will decrease the average moisture content at the location of the interface.

Dryer conditions mean less mould growth, which is why the interfaces are clear where the rest of the board surface shows mould. Note that this effect can be observed on any façade with any kind of cladding or panelling material.

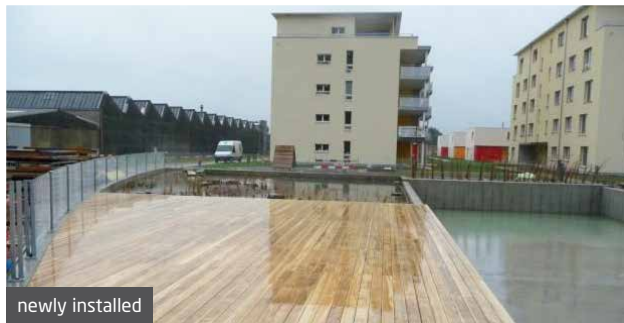
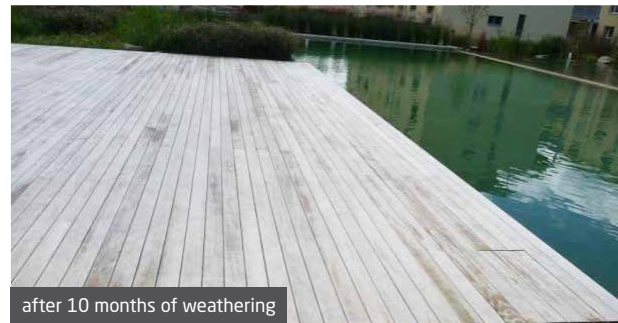
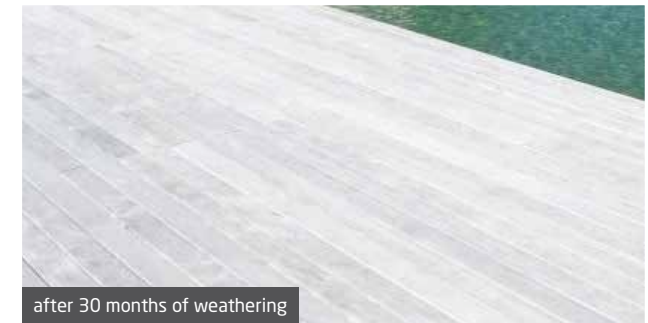
PUBLIC POOL DECKING, OESINGEN, SWITZERLAND

This deck in Oesingen was photographed when newly installed (left), after 10 months (middle) and after 30 months of weathering (right).

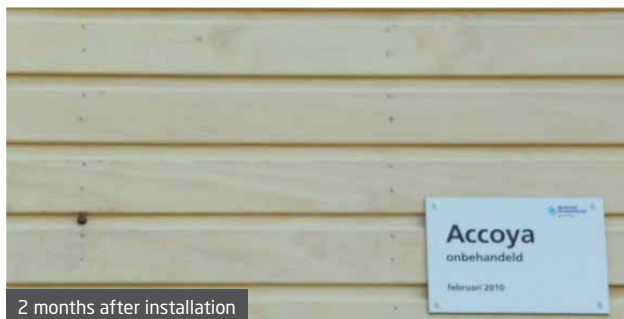
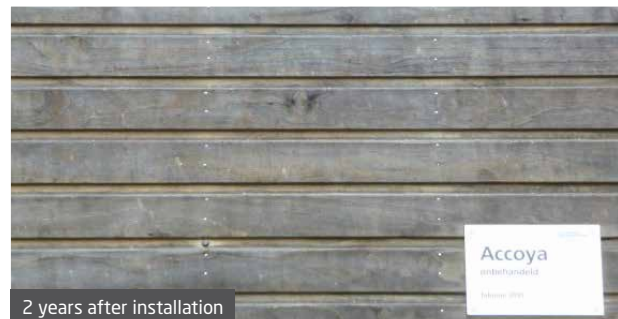
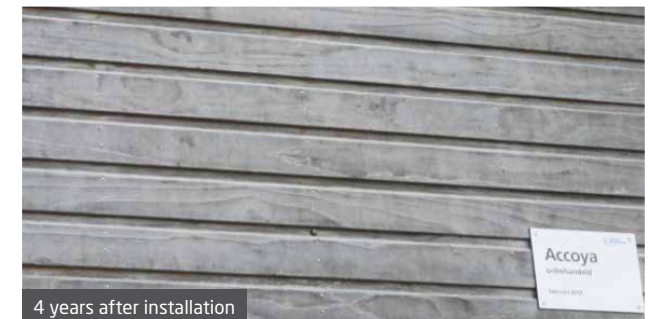
OFFICE CLADDING, VROOMSHOOP, THE NETHERLANDS

A part of the South facing façade was cladded with Accoya® in April 2010, with no maintenance since. The pictures below (left to right) show this cladding in July 2010, 2012 and 2014.

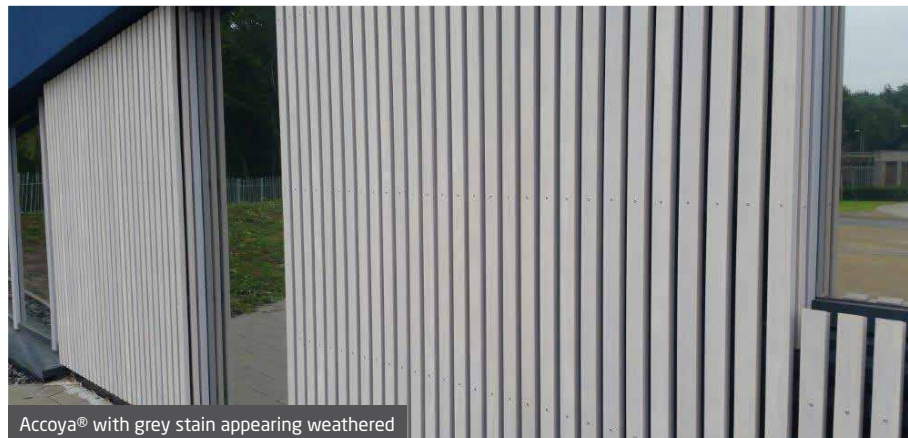
Accoya® with grey stain appearing weathered

Applying a grey stain can give a weathered appearance from the installation of the project, as depicted above.

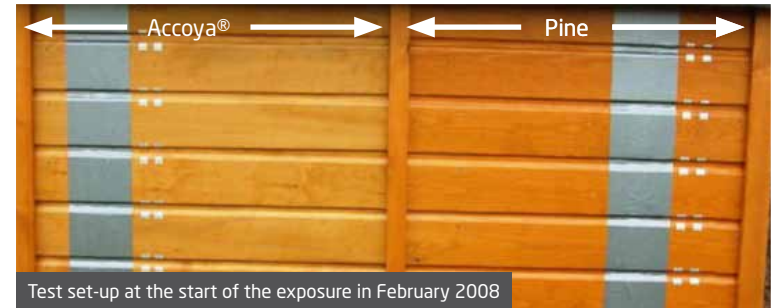
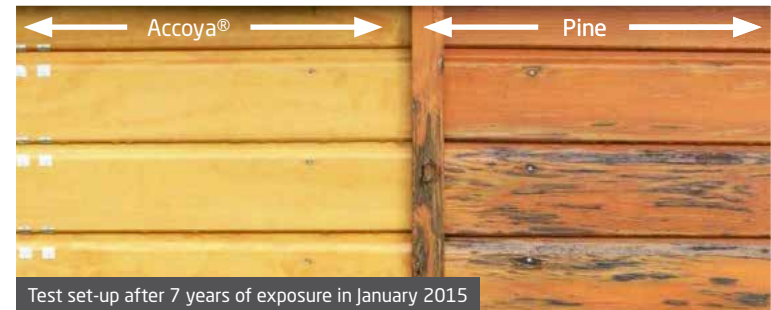
After nearly 7 years of south-facing exposure in a challenging environment the Accoya® boards were found to be in a largely serviceable condition with only 2 of the 7 cladding boards showing discernible evidence of stress in the form of mould or mildew growth.

The pine boards were found to have developed severe blue-stain disfigurement leading to patchy and discontinuous disfigurement beneath the coating. The integrity of the coating on the pine boards was found to be severely compromised. Severe flaking and peeling of the coating had occurred not only along the rounded shoulder details but also on the flat faces where surface fissures and checking had occurred.

A south-facing cladding rig was set up at BM Trada for the comparative performance evaluation of Accoya® and unmodified pine coated with a semi-translucent stain.

The translucent stain system consisted of a pigmented primer with two topcoats. The cladding boards used were machined to a rebated shiplap profile with the upper edge rounded to a radius of $\pm 10\text{mm}$.
