WEATHERING

ABOUT ACCOYA®

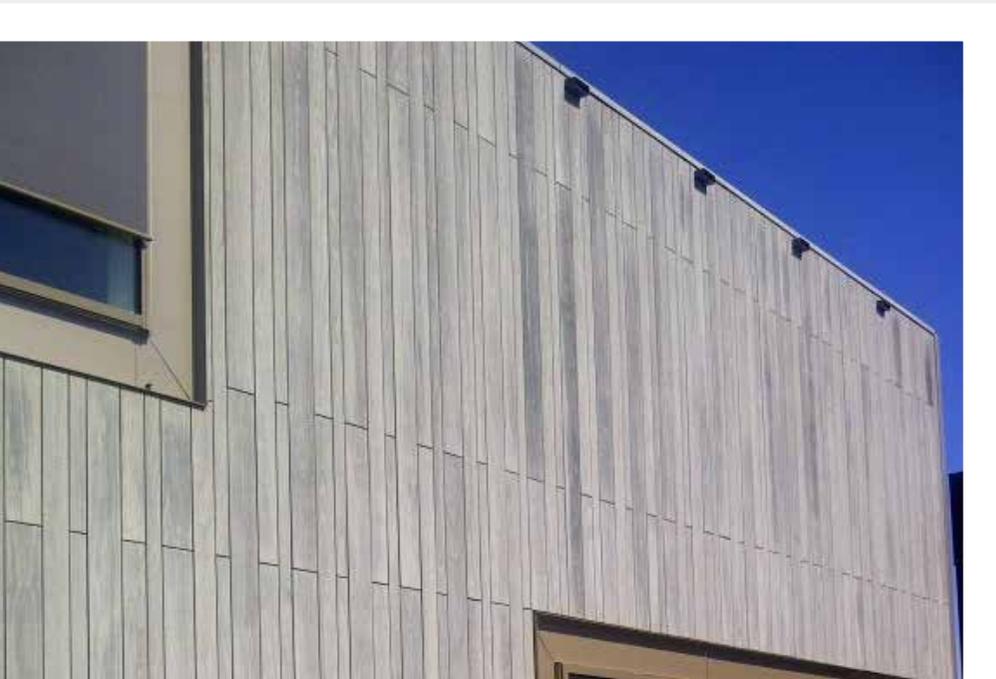
An example of such a blotchy transition period is shown in the image above (Dutch cladding project approximately a year after installation).

However, prior to turning grey, uncoated Accoya® will go through a phase of bleaching where it turns a lighter shade of its normal colour. Surface growths are particularly apparent in this intervening period and can vary in level from board to board. This will become less distinguishable and objectionable after full (even) greying, but in this transition period the surface of Accoya® may look blotchy.

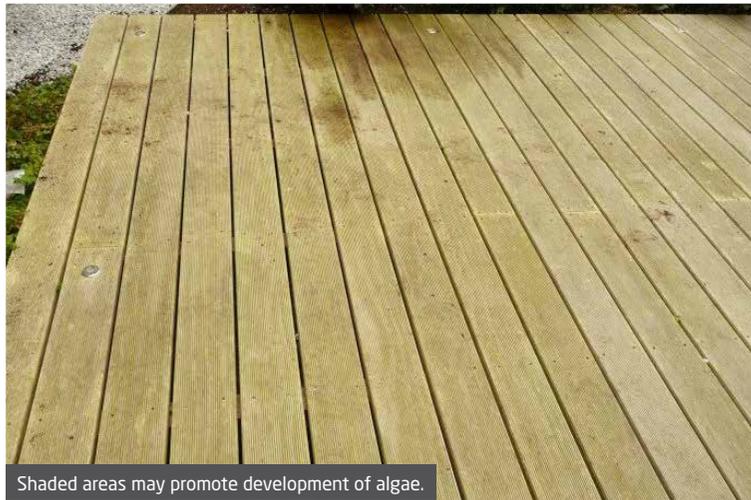
Shaded areas may promote development of algae.

A wet and a dry board may vary in appearance. Due to the installation details, the presence of a shaded area and the natural differences in the wood between boards, as for instance density variation or grain orientation, some may dry quicker than others.

Not only does this reflect on the appearance of a surface while drying, it will also have an influence on the development of moulds, algae and so on.

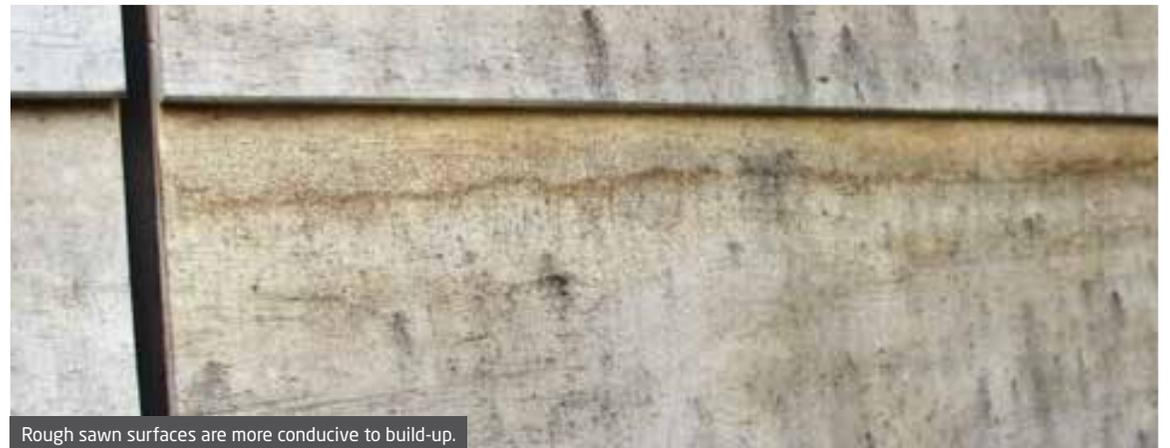
Rough sawn surfaces are more conducive to build-up.

Other influences are location specific, such as proximity to vegetation, pollution and dirt accumulation (rough sawn surface!). Lastly, the natural differences in the wood will also play a role.

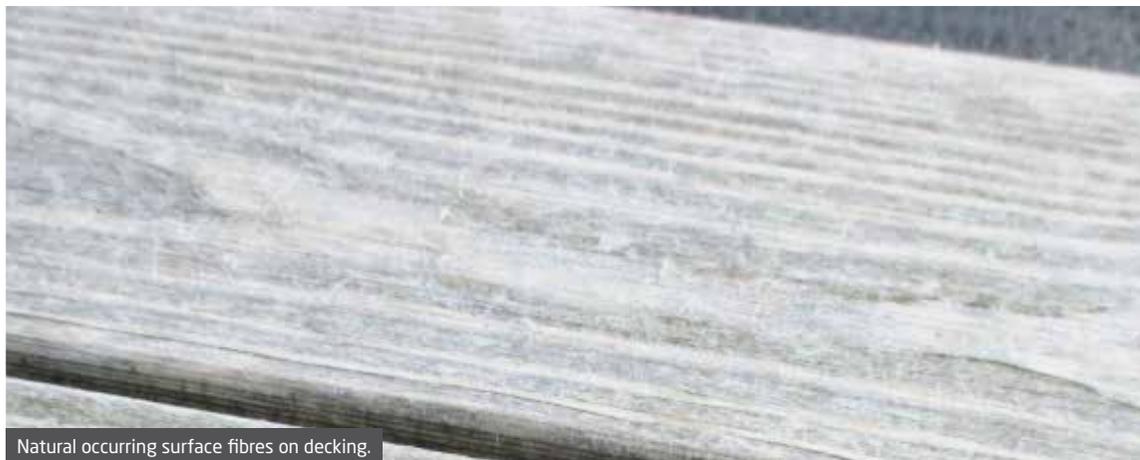
Natural occurring surface fibres on decking.

The higher the amount or intensity of UV the surface is subject to, the faster this process will develop. It should be noted that these fibres are formed on all exposed wood species, including Accoya®, particularly on flat surfaces like decking. A ribbed deck profile will tend to cause an accumulation of these fibres, making it all the more noticeable.

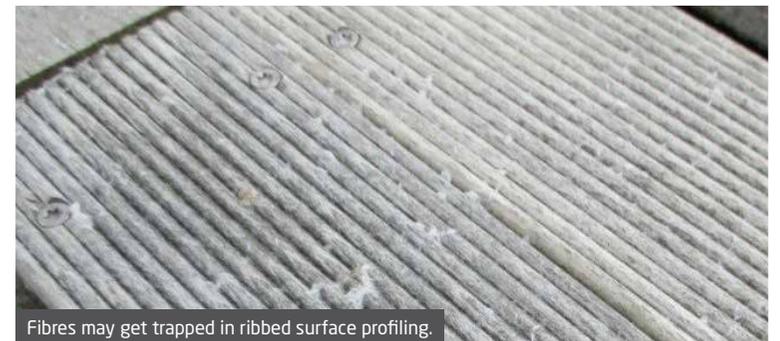
Fibres may get trapped in ribbed surface profiling.

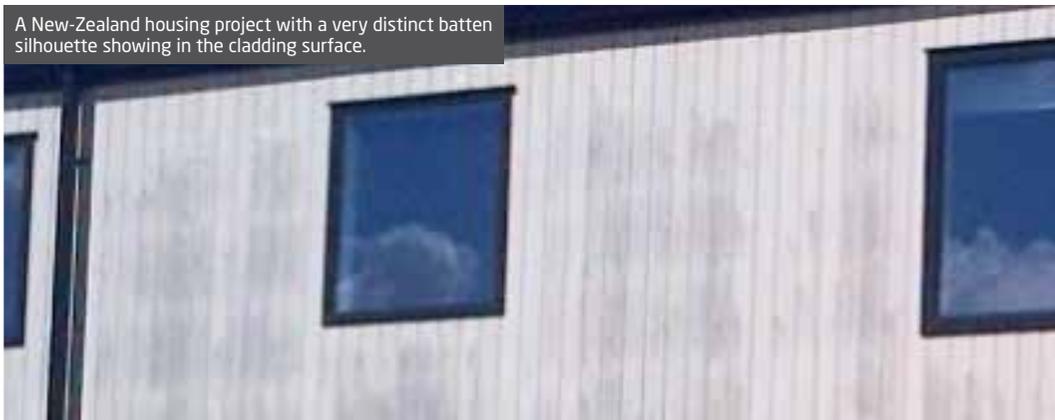
A New-Zealand housing project with a very distinct batten silhouette showing in the cladding surface.

Some projects have shown a distinct pattern reflecting the sub-frame behind the Accoya®. This is caused by heat transfer from the building to the Accoya® boards, which will decrease the average moisture content at the location of the interface.

Dryer conditions mean less mould growth, which is why the interfaces are clear where the rest of the board surface shows mould. Note that this effect can be observed on any façade with any kind of cladding or panelling material.

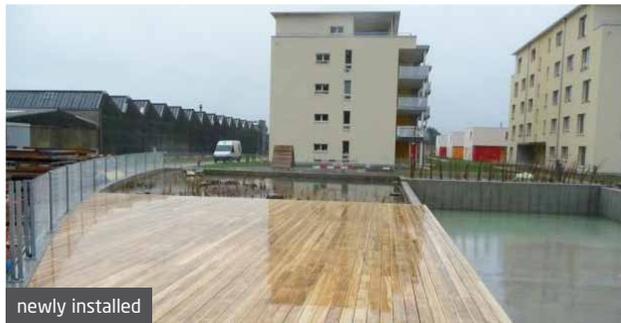
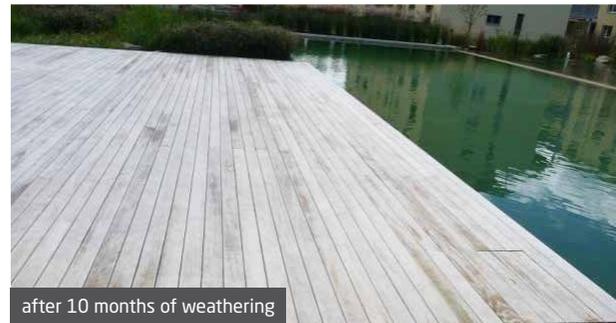
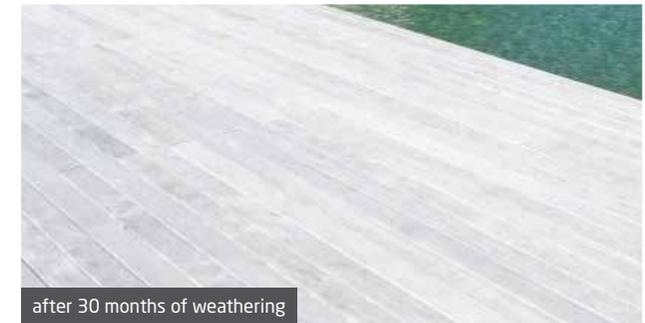
PUBLIC POOL DECKING, OESINGEN, SWITZERLAND

This deck in Oesingen was photographed when newly installed (left), after 10 months (middle) and after 30 months of weathering (right).

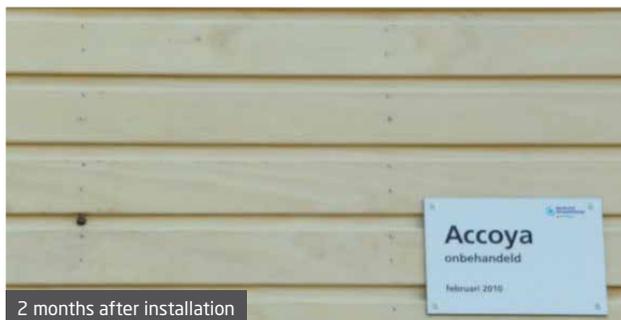
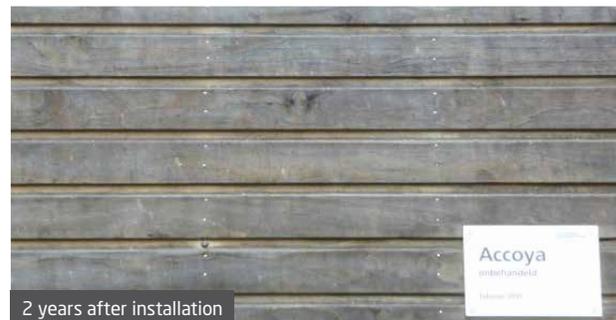
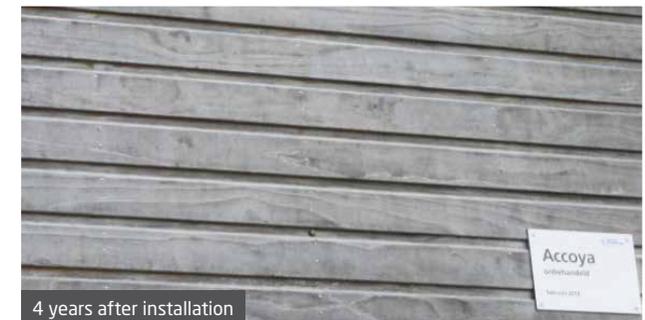
OFFICE CLADDING, VROOMSHOOP, THE NETHERLANDS

A part of the South facing façade was cladded with Accoya® in April 2010, with no maintenance since. The pictures below (left to right) show this cladding in July 2010, 2012 and 2014.

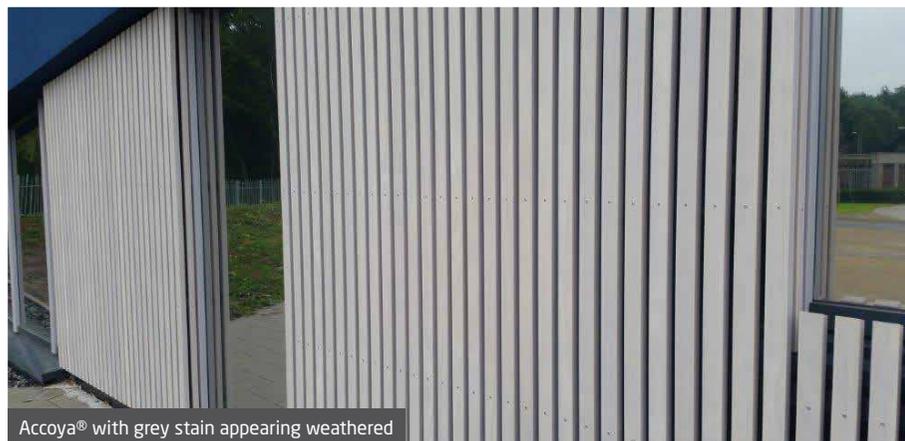
Accoya® with grey stain appearing weathered

Applying a grey stain can give a weathered appearance from the installation of the project, as depicted above.

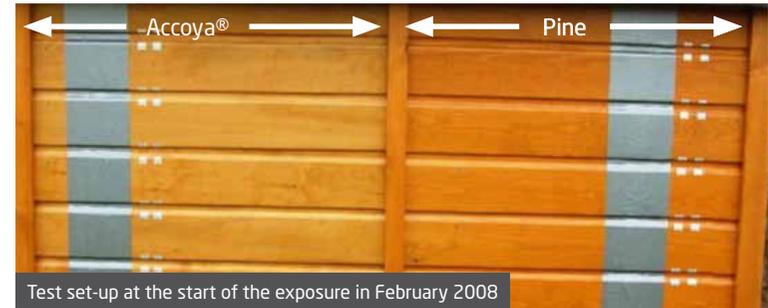
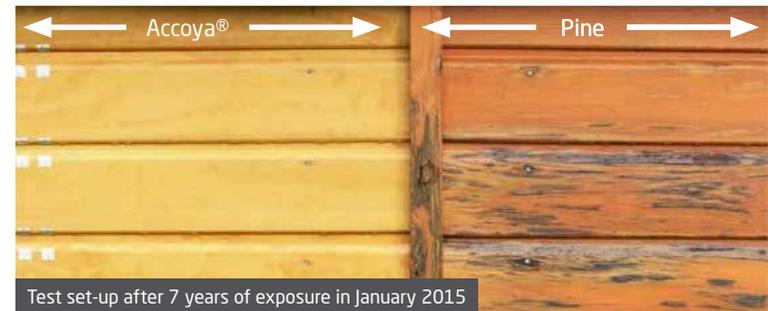
A south-facing cladding rig was set up at BM Trada for the comparative performance evaluation of Accoya® and unmodified pine coated with a semi-translucent stain.

The translucent stain system consisted of a pigmented primer with two topcoats. The cladding boards used were machined to a rebated shiplap profile with the upper edge rounded to a radius of ± 10 mm.

After nearly 7 years of south-facing exposure in a challenging environment the Accoya® boards were found to be in a largely serviceable condition with only 2 of the 7 cladding boards showing discernible evidence of stress in the form of mould or mildew growth.

The pine boards were found to have developed severe blue-stain disfigurement leading to patchy and discontinuous disfigurement beneath the coating. The integrity of the coating on the pine boards was found to be severely compromised. Severe flaking and peeling of the coating had occurred not only along the rounded shoulder details but also on the flat faces where surface fissures and checking had occurred.
